Manhole Inspection Summary

Manhole # S09A1_013MH

Insp Date: **5/14/08 2:43 PM**

Location Address: **1260 Benson AV**

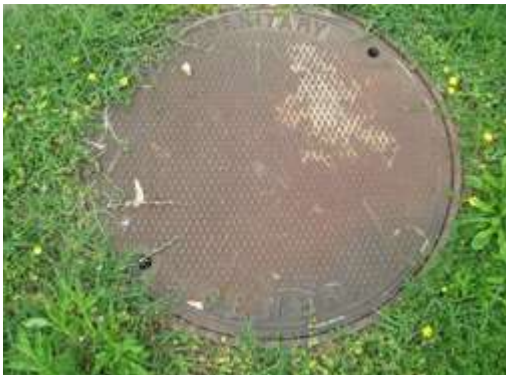
lid pic

Condition: **Sound**

Cover Material: **Cast Iron**

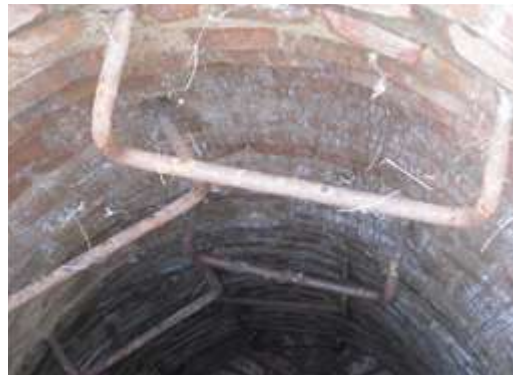
Defect 1

Count: **9** Missing: **0** ☒ **Corroded**

oxidized rungs

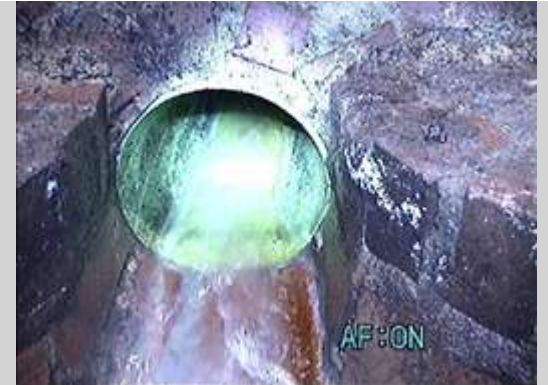
12 O'Clock Outflow

8 in. Circular Gravity Sewer
Pipe Out @ 12 O'Clock

Pipe Height: **8.4** (in.) Rod and Bar (Angled)
Pipe Material: **PVC** ☐ Pipe Lined
Invert Depth: **13.48** (ft.) Flow Characteristics: **Slow**
Deposits: ☒ None ☐ Mud ☐ Sludge ☐ Debris ☐ Grease
Silt Depth: **0** (in.) Deposits Extent:
Infiltration: **None** Pipe Seal Cond: **Sound**

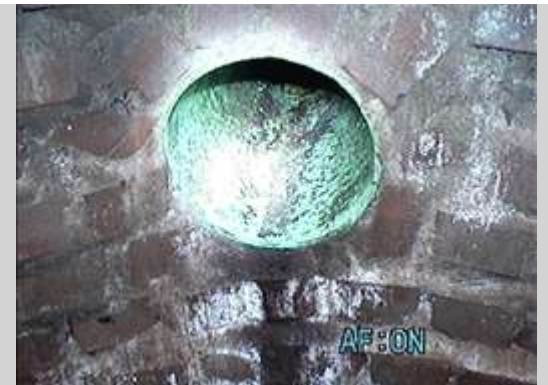
3 O'Clock Inflow

8 in. Circular Gravity Sewer
Pipe In @ 3 O'Clock

Pipe Height: **8.4** (in.) Rod and Bar (Angled)
Pipe Material: **PVC** ☐ Pipe Lined
Invert Depth: **7.96** (ft.) Flow Characteristics: **Fast**
Deposits: ☒ None ☐ Mud ☐ Sludge ☐ Debris ☐ Grease
Silt Depth: **0** (in.) Deposits Extent:
Infiltration: **None** Pipe Seal Cond: **Sound**

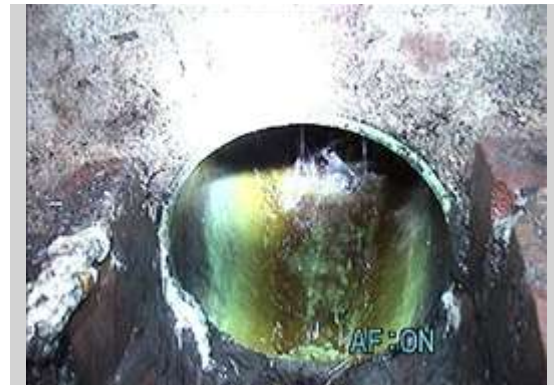
Drop In @ 3 O'Clock

Drop: **Inside** Rod and Bar
Angled: **Yes** Reading: **12.28** (ft.)
Inv Depth: **13.28** (ft.)
Drop Condition: **Open**

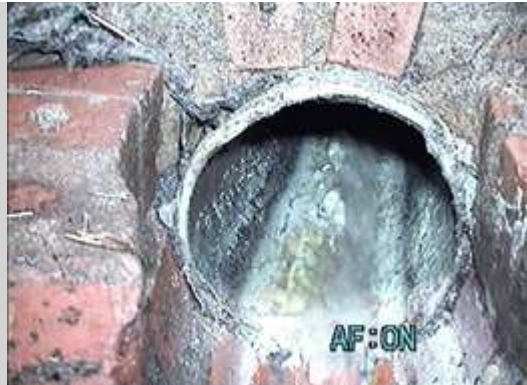
9 O'Clock Inflow

Pipe In @ 9 O'Clock

Invert Depth: **13.38** (ft.) Flow Characteristics: **Slow**

Infiltration: **None** Pipe Seal Cond: **Sound**
